# Case study: South Australia Defence

## Overview

South Australia Defence approached Cleanrooms Australia to design and build a cleanroom facility they could use to service and test valves that play a vital role in the hydraulic trolley system used to service ships for the Australian Defence Force.

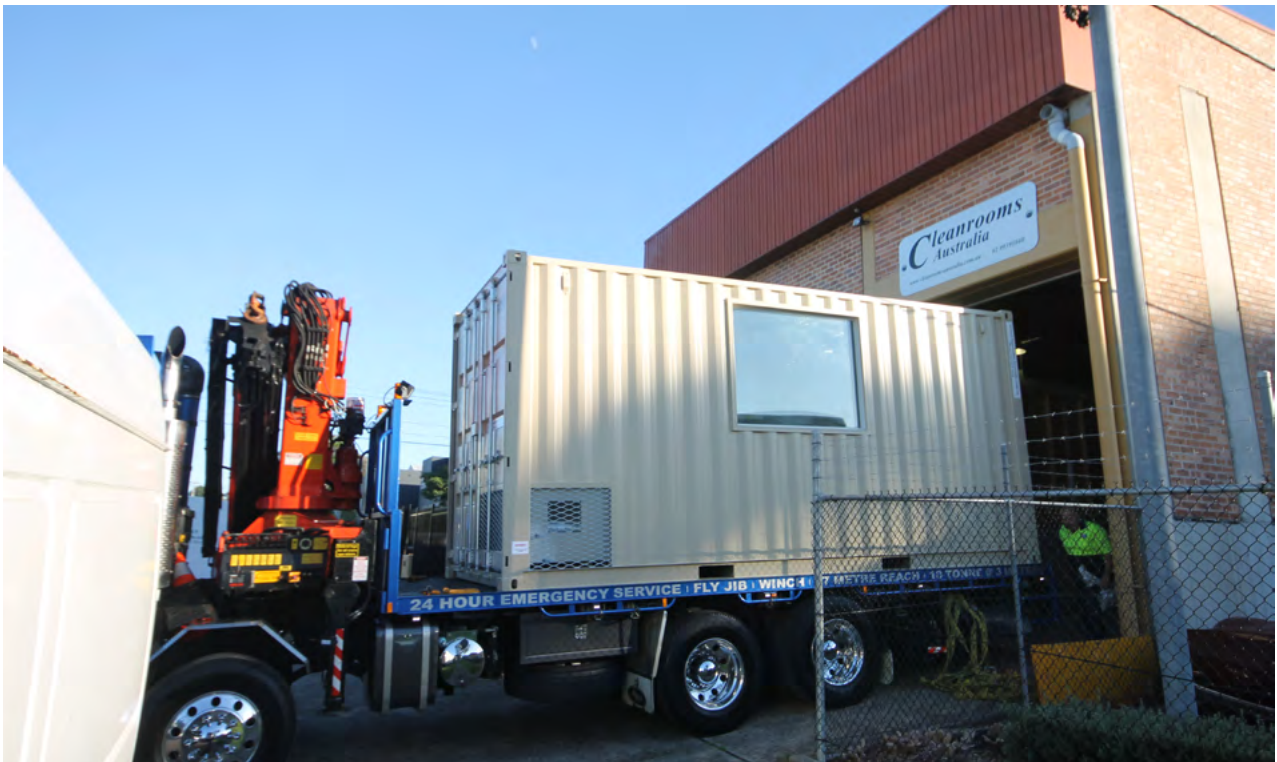
Cleanrooms Australia designed, built and delivered an ISO 14644 Class 8 compliant cleanroom contained within a 20-foot shipping container that is currently in successful operation at the client's South Australian facility.

As per client requirements Cleanrooms Australia designed and built a shipping container cleanroom with the provision for South Australia Defence to install a number of pumping and testing rigs on one external end of the cleanroom.

Weight certified benches were also installed inside the cleanroom, along with oil sinks with contained drainage so maintenance staff could drain the oil out of the valves inside the cleanroom before cleaning and testing.
